90-102 Regent Street, Redfern

Report for Above Ground Vibration Monitoring

Project ID	20211177.8
Document Title	Report for Above Ground Vibration Monitoring
Attention To	Richard Crookes Constructions Pty Ltd

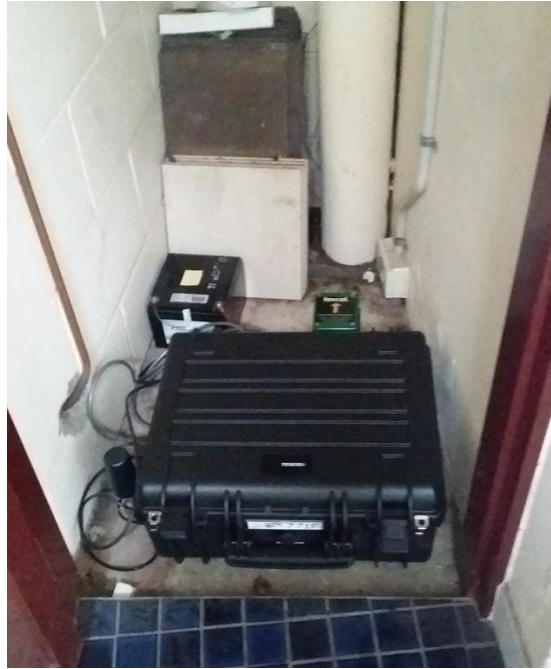
**Figure 2 – Vibration Monitor Location**

The vibration monitor installation location is shown in Figure 2. The vibration sensor (geophone) in the ex-Church is adhered to the on-grade ground slab. The foundation monitoring location is suitable for construction vibration monitoring at the receiving structures

Vibration monitor
